Seafloor Environments North St. Croix Margin and Virgin Islands Trough

FPD-1-82 (28)
December 1982

Seafloor Geosciences Division
Ocean Science and Technology Laboratories
Naval Ocean Research and Development Activity
NSTL, Mississippi 39529

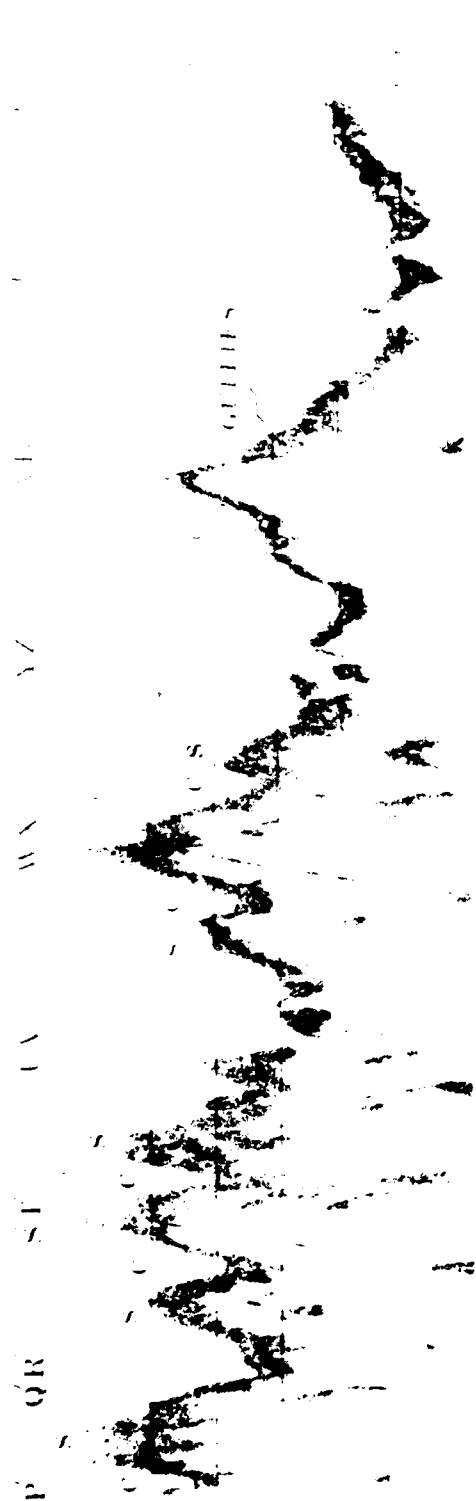
Figure 2.7. Seismic reflection profile showing the south wall of the Virgin Islands Trough and multiple crossings of Christiansted Canyon (C) and Salt River Canyon (S); 1 sec = 750 m in water and about 1000 m in sediment.

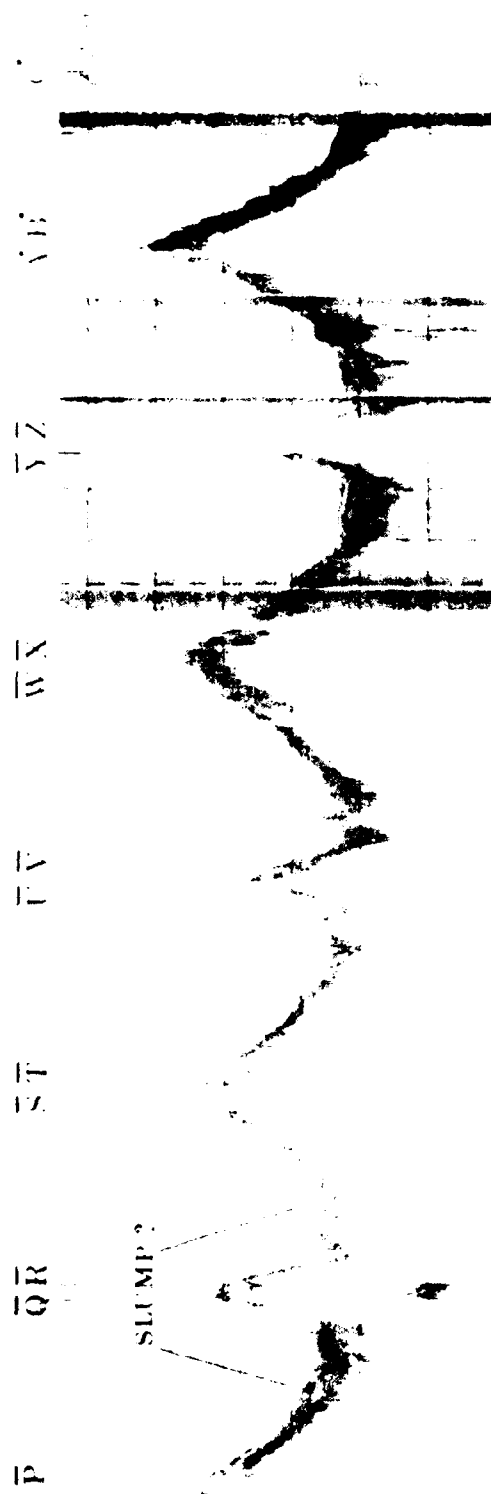
Figure 2.9. Seismic reflection profile showing north-south crossings of Virgin Islands Trough; 1 sec = 750 m in water and about 1000 m in sediment.

observed in the slope sediments are highly indicative of slope failure or incipient slumping although, as noted in Part 2.4.2, evidence indicates that slumping is not a major process. Despite the steepness of the slope off St. Croix, the sediment thickness may not be great enough to develop sufficient shearing stress for large-scale, spontaneous slumping to occur. On the other hand, slumping may be a significant process on the north wall of the VIT, which is also steep, has a relatively thick sediment cover and is the locus of seismicity in the VIT. Indeed, the seismic reflection profiles of the north wall (Figs. 2.6 and 2.9) show terrace-like steps which may be slump scar features.
